AFRL-ML-WP-TR-2004-4196

**ENDURANCE PUMP TEST WITH MIL-PRF-83282 HYDRAULIC FLUID,
PURIFIED WITH MALABAR
PURIFIER**

JUNE 2004

Interim Report for 01 January 2002 – 01 June 2004

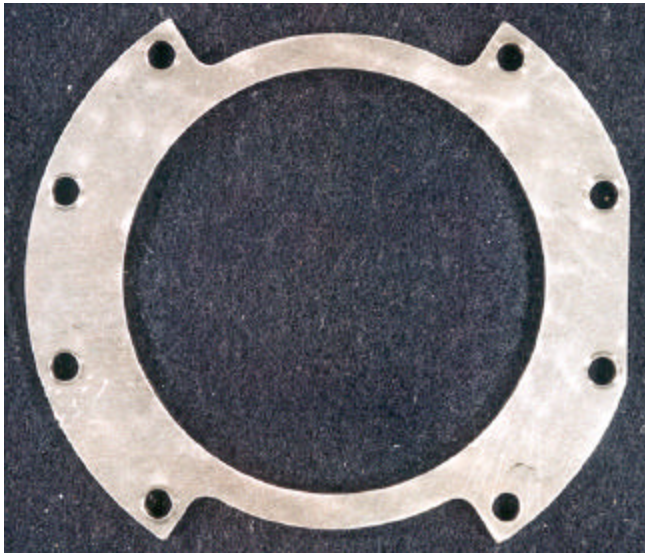
Mounting Flange at 1500 Hours
Purified Fluid

- k) The remaining internal critical surfaces like the compensator assembly, the control guide and springs, as well as the housing and mounting flange show no debris deposits or discernible wear.
